Shared Use

Operational Review

2012

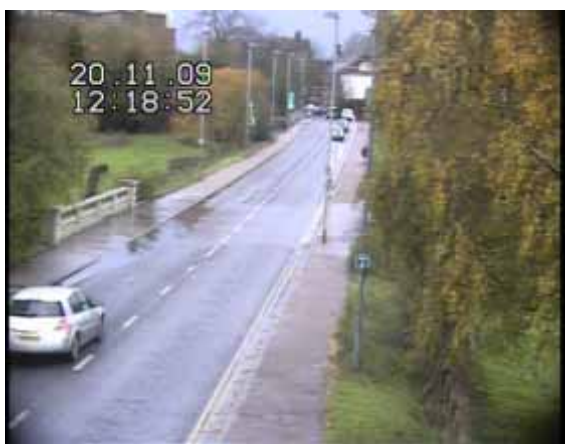
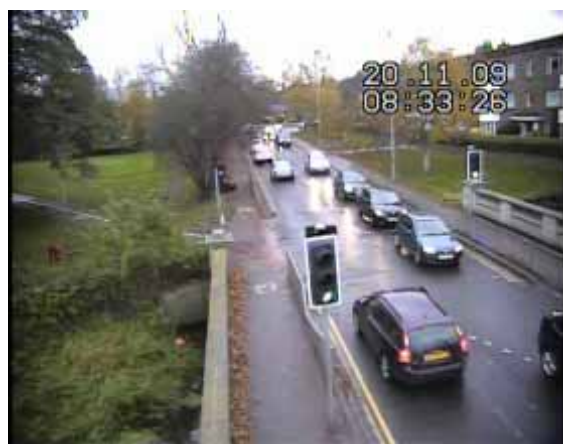
Figure 1 – Unsegregated route alongside the Fen Causeway (Left: link section and Right: junction with route through park)

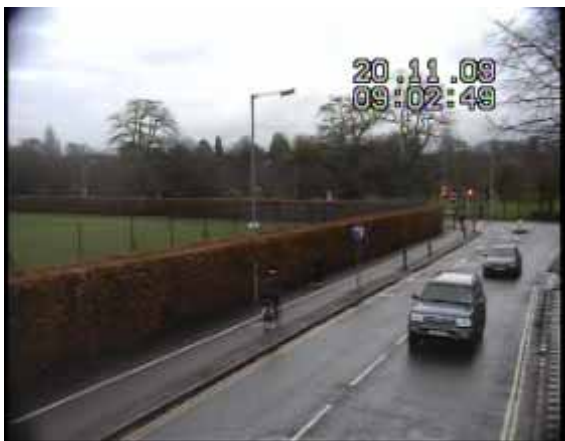
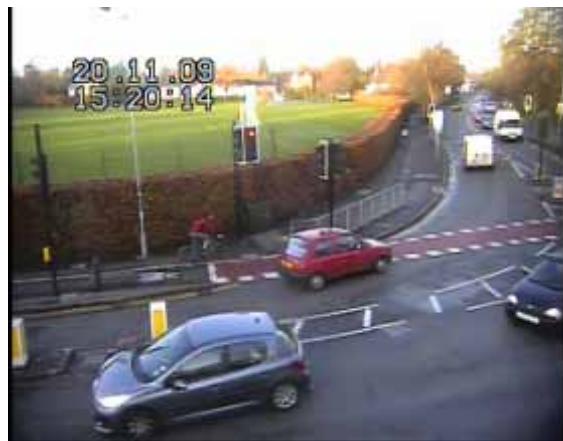
Figure 2 – Segregated route on Barton Road (Left: link section and Right: junction on Barton Road)

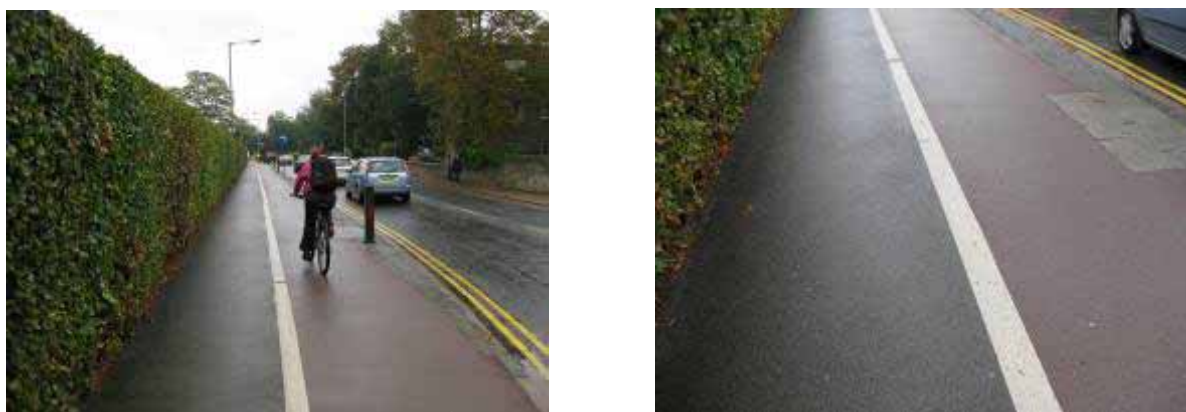
Figure 5 – (Left) Cyclist in segregated cycle track, and (Right) detail of segregation on Barton Road.

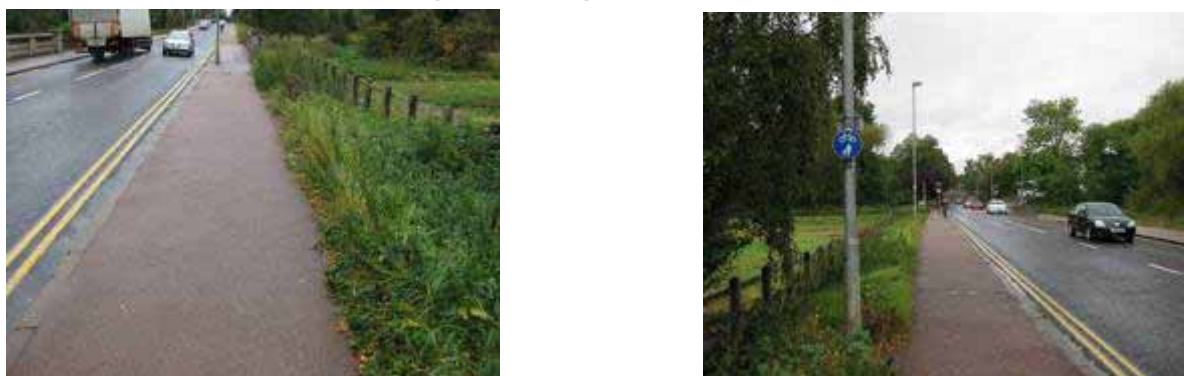
Figure 7 – (Left) Detail of route bounding, and (Right) shared use designation on The Fen Causeway.

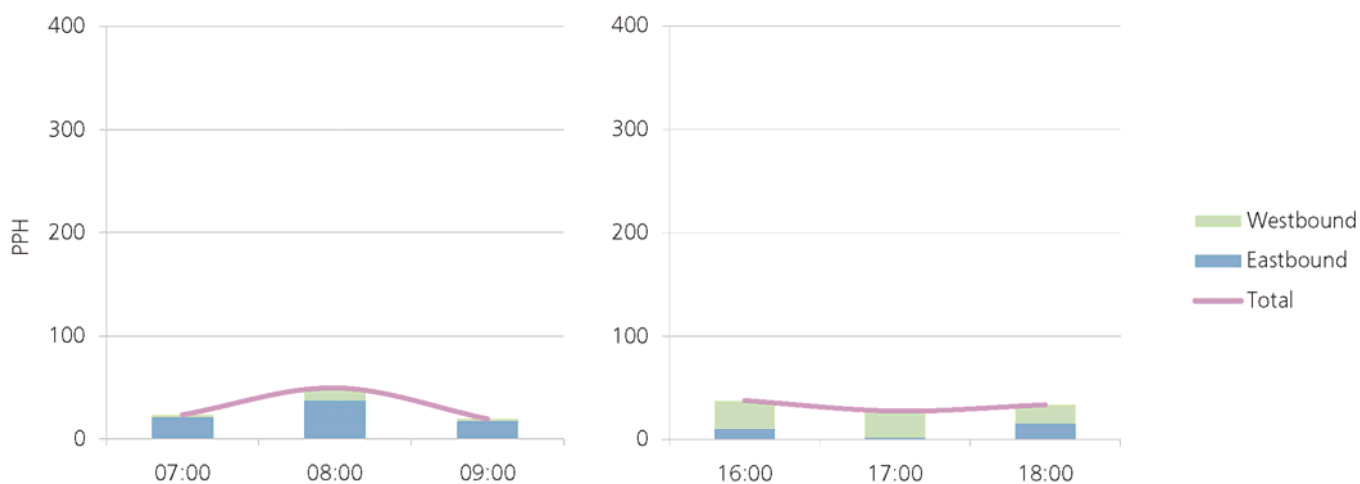
Figure 10 - Pedestrian Activity (Weekday)

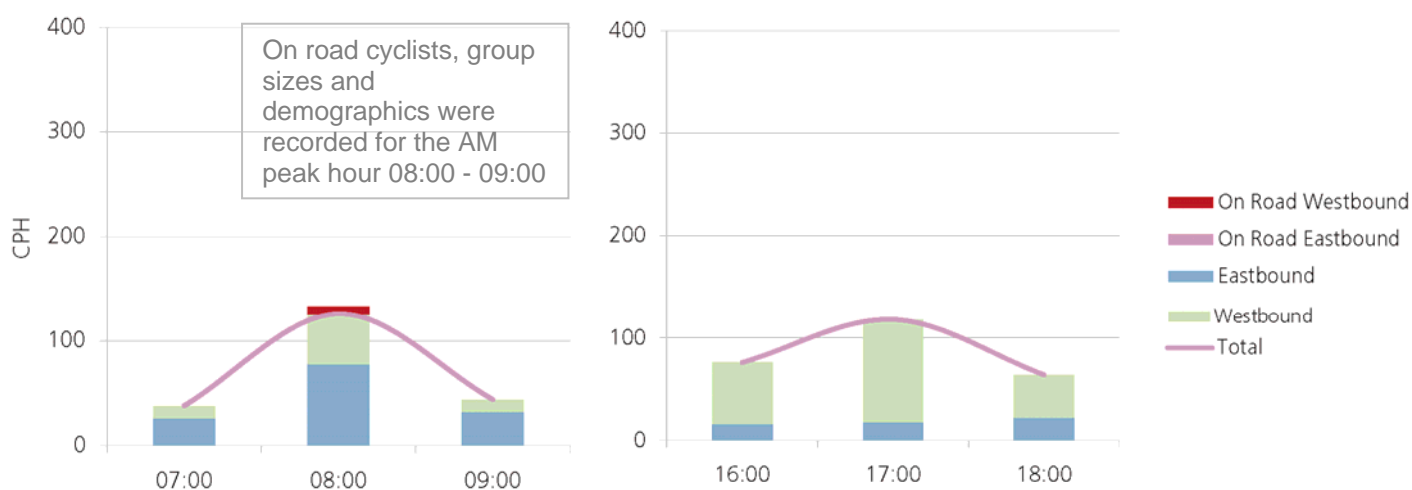
Figure 10 - Cyclist Activity (Weekday)

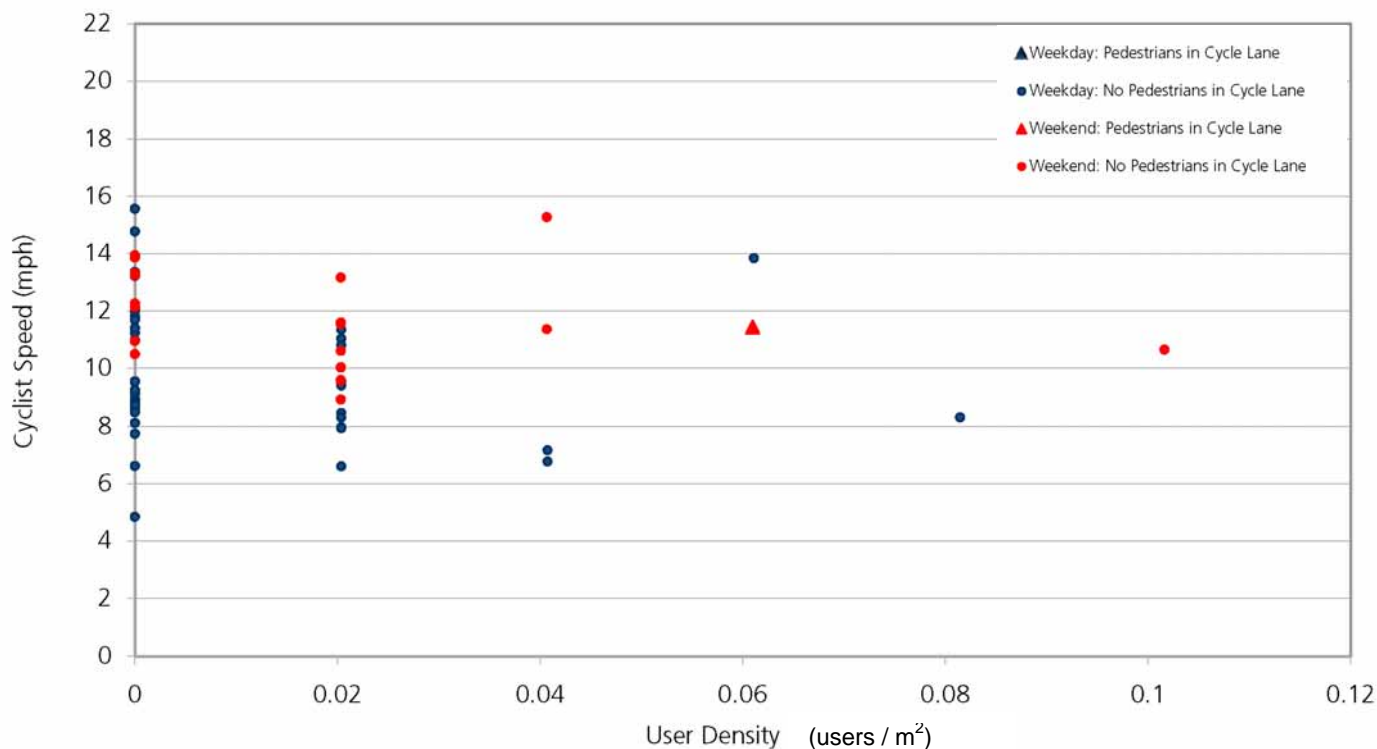
Figure 21 – Cyclist speed and user density chart (segregated site)

- 4.6.2 Figures 21 and 22 show how user density on the segregated and unsegregated facilities affected cycle speed. The findings suggest that cycle speeds on the segregated shared use facility are not significantly affected by user density. On the unsegregated facility, maximum cycle speeds decreased with small increases in user density, though there was insufficient activity on the route to assess how this trend is affected by a larger range of user densities.

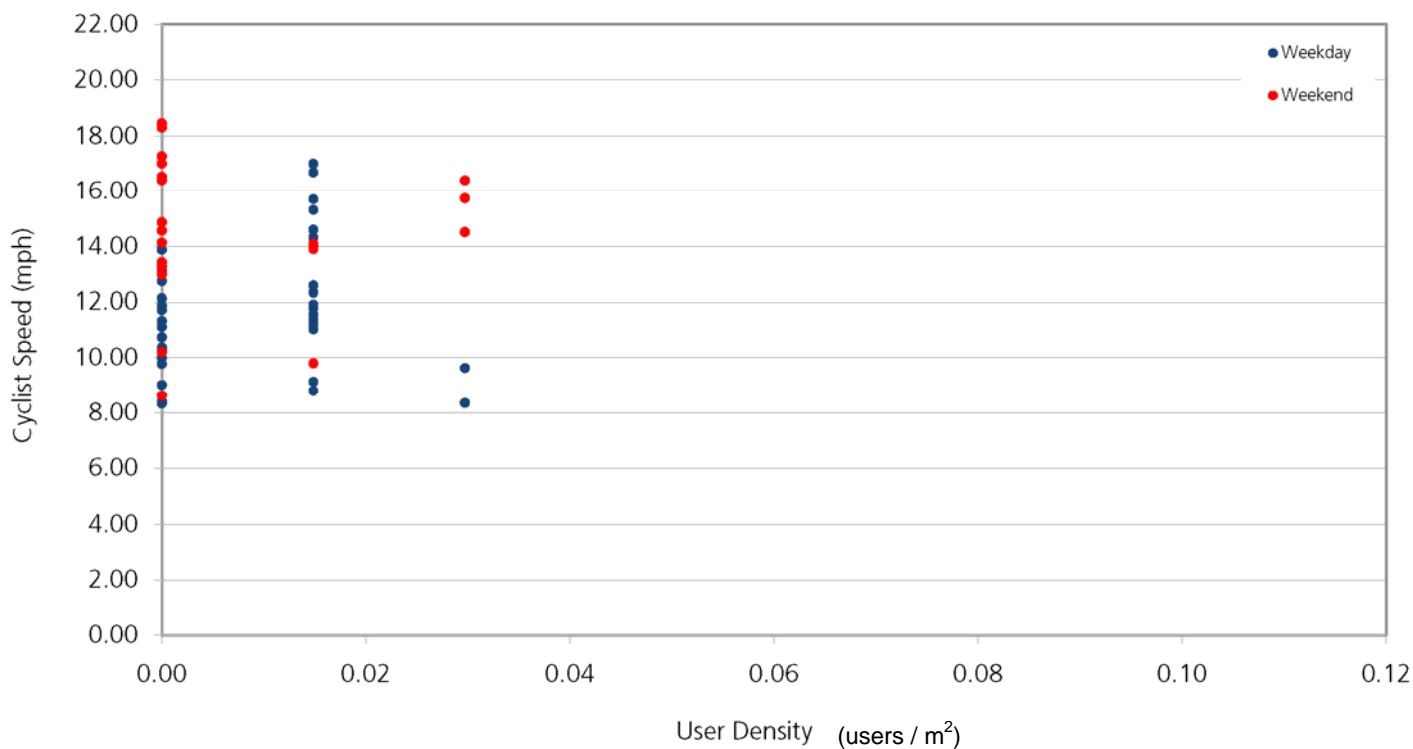
Figure 22 – Cyclist speed and user density chart (unsegregated site)

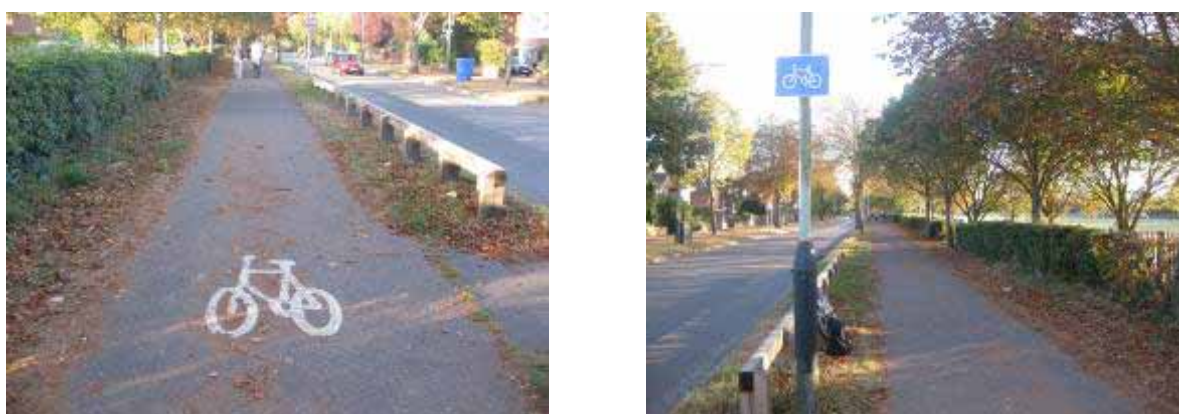
Figure 30 – (Left and Right) Shared use on Bluebell Road is not correctly signed.

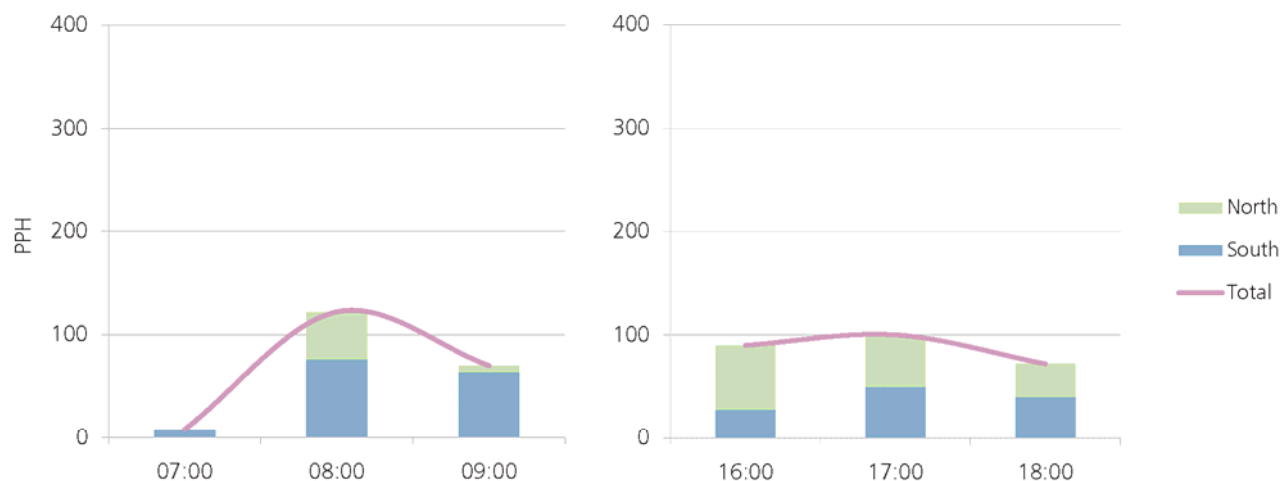
Figure 31 - Pedestrian Activity (Weekday)

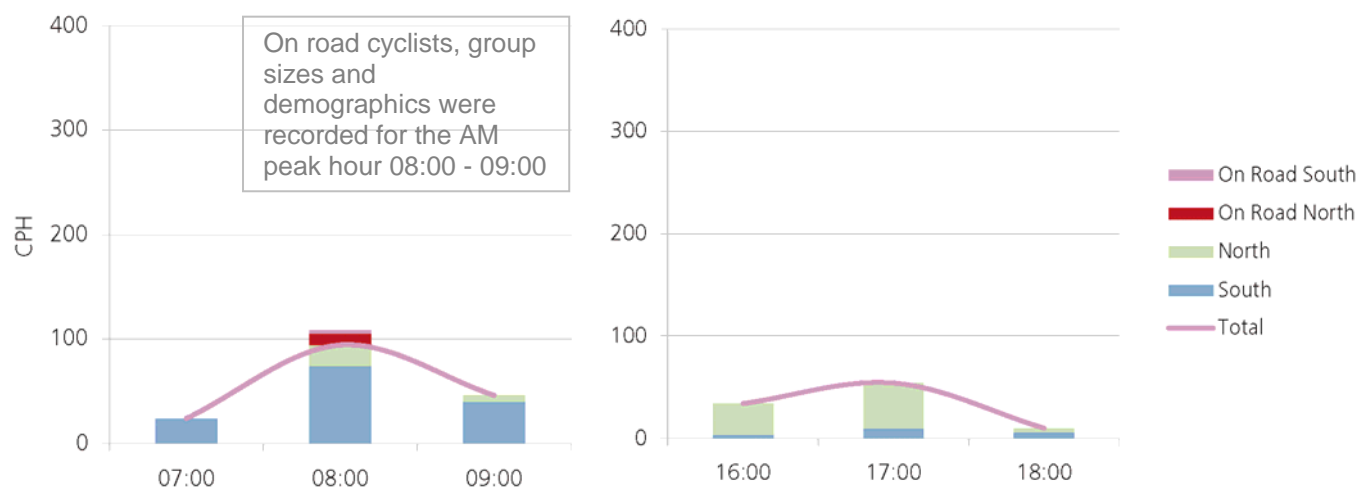
Figure 32 - Cyclist Activity (Weekday)

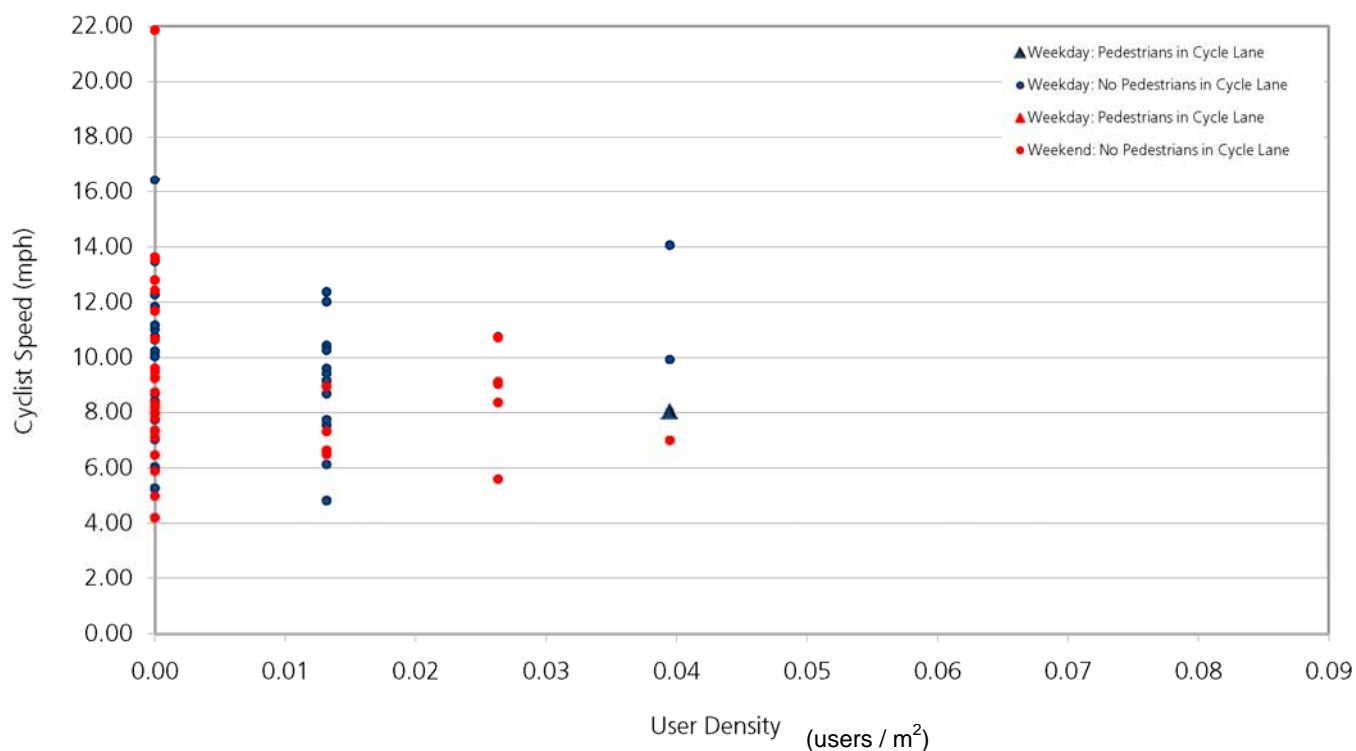
Figure 44 – Cyclist speed and user density chart (Segregated site)

- 5.6.2 The figures overleaf show how user density on the segregated and unsegregated facilities affects cycle speed. The findings suggest that cycle speeds on the segregated shared use facility are not significantly affected by user density. On the unsegregated facility, there is a clear trend showing cycle speeds markedly decreasing as user density increases.

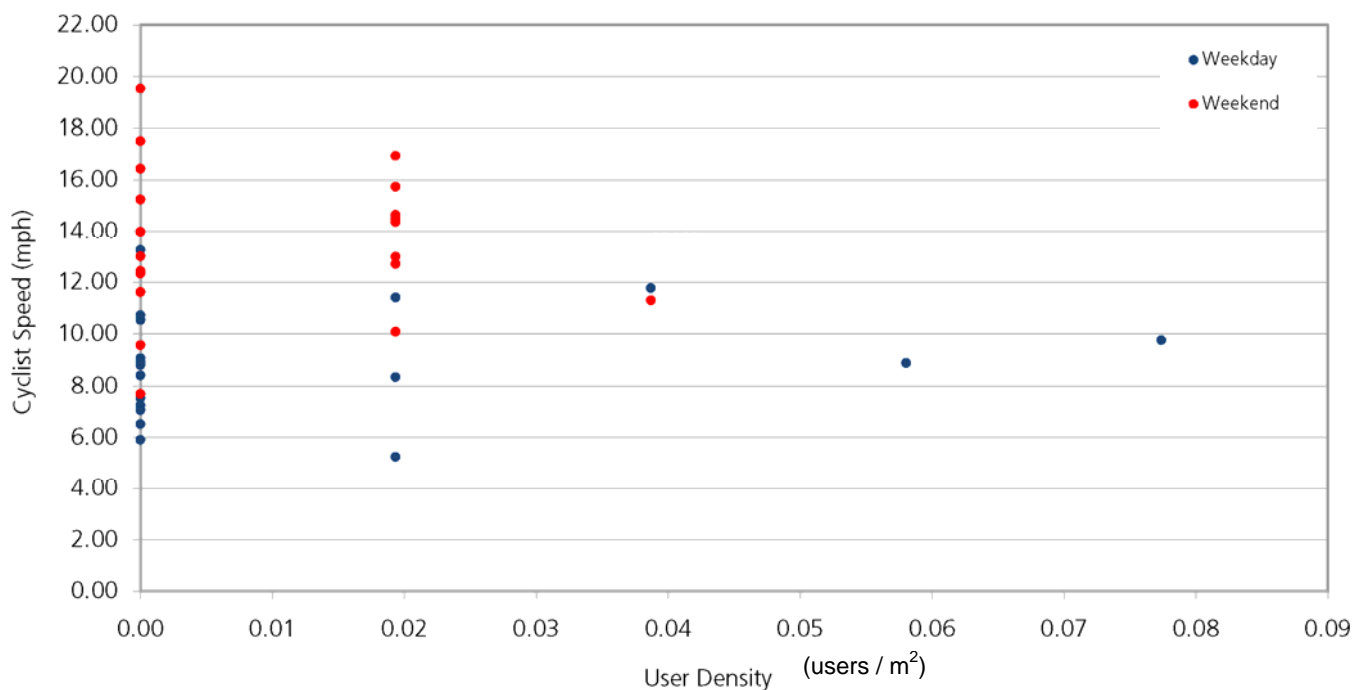
Figure 45 – Cyclist speed and user density chart (Unsegregated site)

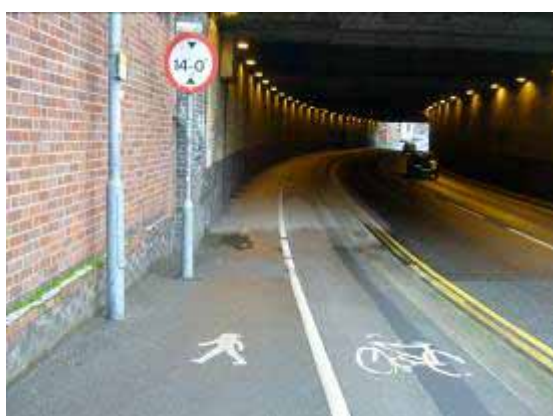
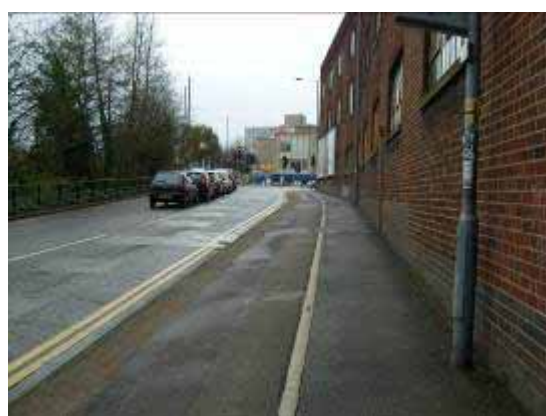
Figure 48 – (Left) Shared use designation, and (Right) building edge on route at Cattle Market Road.

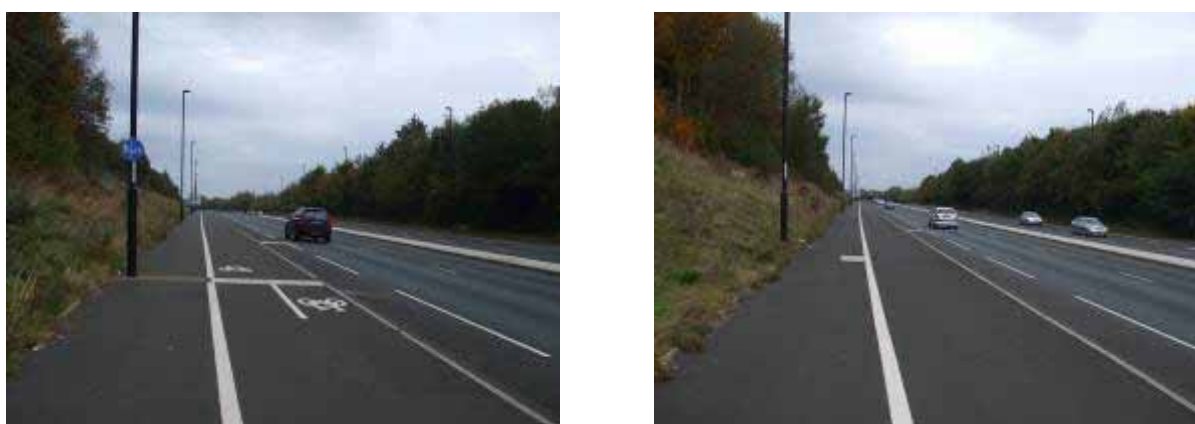
Figure 57 – (Left) Shared use designation, and (Right) clear lines of sight on Scotswood Road route.

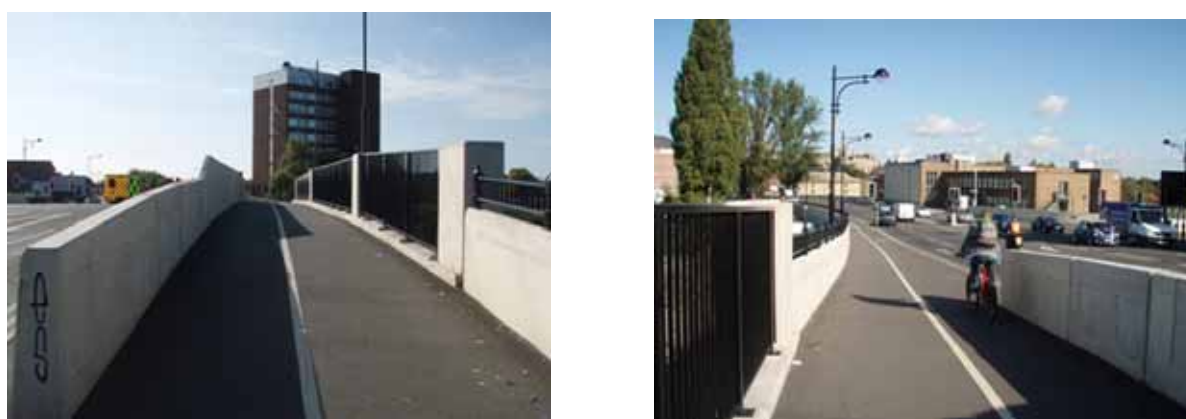
Figure 66 – (Left) Raised gradient evident on route, and (Right) cycle track bounded by roadside concrete wall adjacent to London Road.

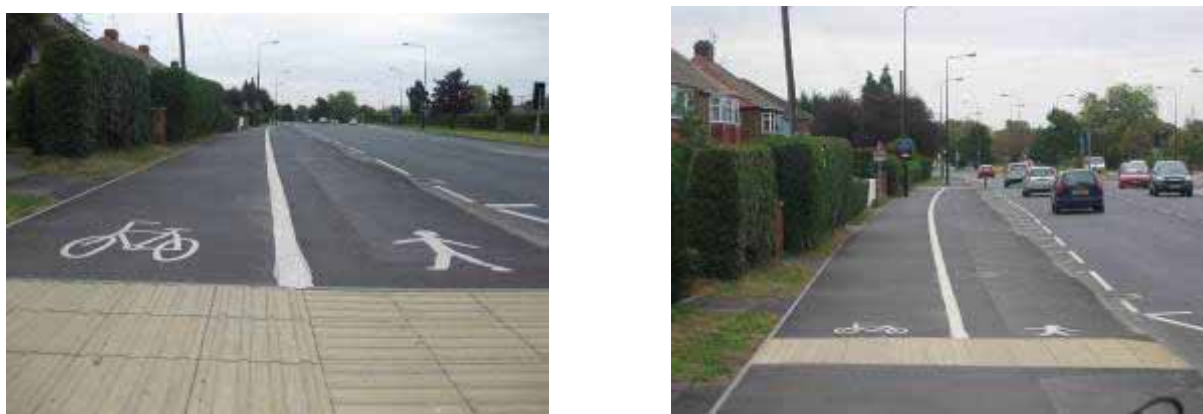
Figure 75 – (Left) Shared use designation and (Right) wider context of route adjacent to Hull Road. Note roadside position of footway.
